User Perceptions of Bus Stop Bypasses:

Intercept Surveys of Pedestrians and Cyclists

Completed in collaboration with Wellington City Council as part of the Victoria University of Wellington Summer Research programme

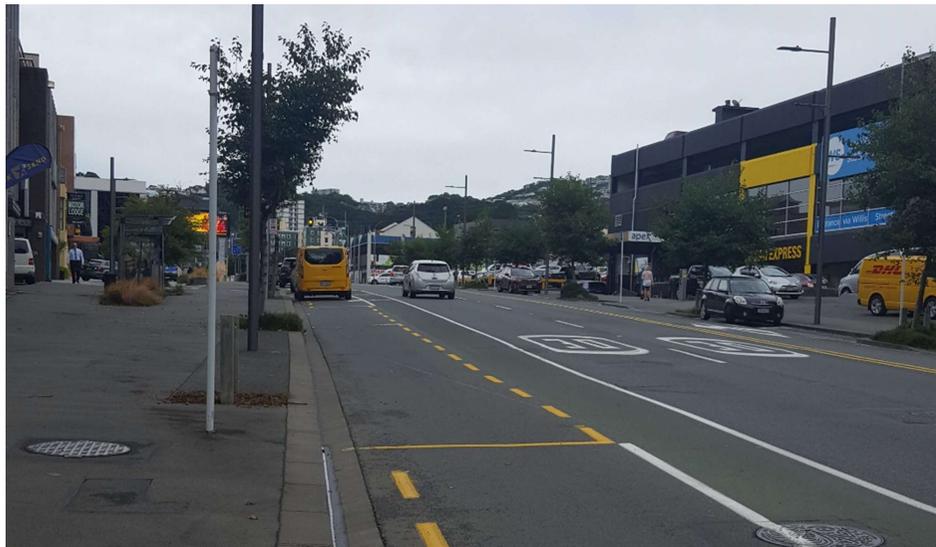
Stop 6710, Victoria St at Ghuznee St (Victoria St A (Control))

Control site. Cycle lane passes between the bus and moving traffic. Outbound. Daily boardings: 79, alightings: 86, total: 165

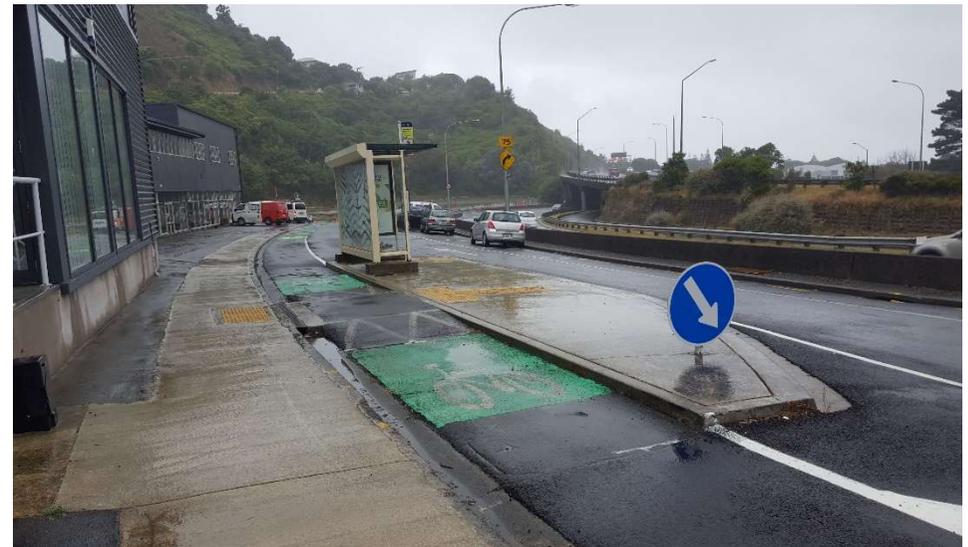
Stop 3254, Centennial Highway at Glover St, Ngauranga

Cycle lane passes behind bus shelter. Pedestrian crossing to bus stop island is marked by a raised section of the cycle lane and tactile paving. Inbound. Daily boardings: 27, alightings: 11, total: 38

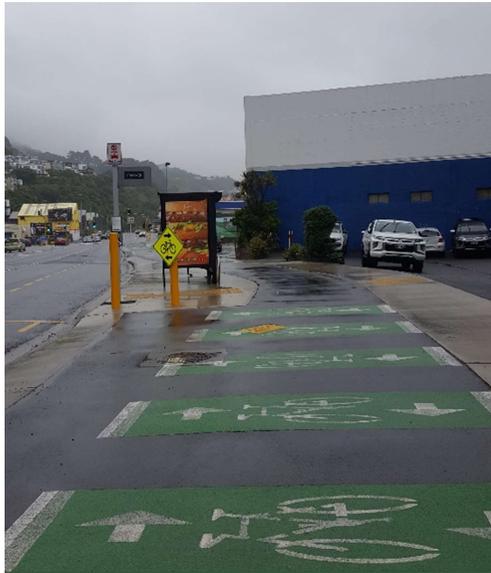
View of Hutt Rd site from the South

Bidirectional cycleway passes behind bus shelter. Pedestrian crossing to bus stop island is marked by tactile paving south of the stop.
Inbound. Daily boardings: 111, alightings: 48, total: 159

Marked pedestrian crossing: A zebra crossing may be a design option that increases the perception of safety not only for pedestrians, but also for cyclists. A few cyclists mentioned that they would like a crossing at the Hutt Rd stop like the one at another site along Hutt Rd. A TRL study of pedestrian crossings at bus stop bypasses found that more pedestrians used a zebra crossing compared to an uncontrolled crossing when accessing a bus stop island.²⁶ This could help manage where pedestrians choose to cross and reduce the likelihood that they will cross at the blind corner.

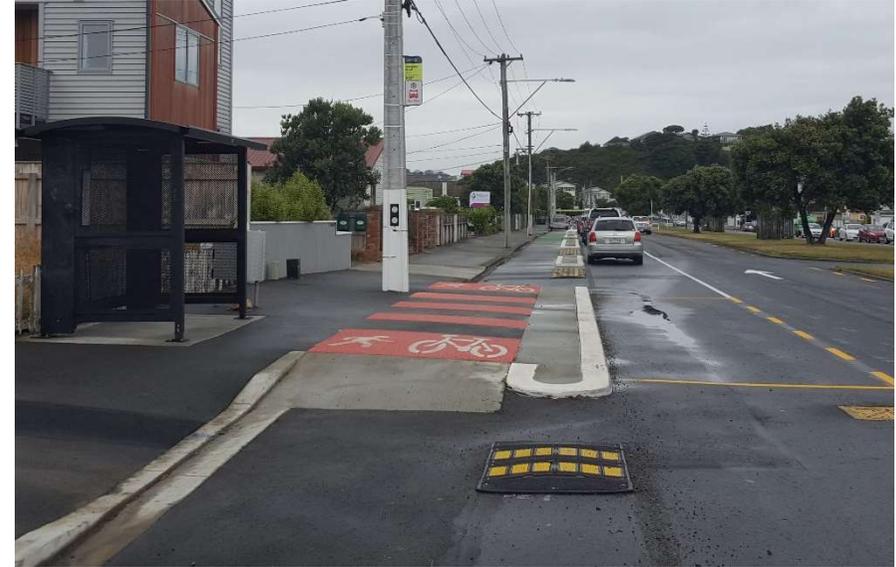
Stop 6027, near 119 Rongotai Rd

Cycleway passes between bus shelter and bus bay. Shared zone for cyclists and pedestrians is denoted by red stripes and painted symbols.
Outbound. Daily boardings: 36, alightings: 58, total: 94

Dedicated cycle lane between shelter and bus bay: The designs at Rongotai Rd and Victoria St B situate a dedicated cycle lane between the shelter and the bus bay. This layout requires pedestrians to cross the lane at the time that the bus arrives, as well as to alight the bus directly onto the cycle lane. Pedestrians frequently commented either that the site was unsafe because the layout was unexpected (Victoria St B) or that alighting the bus was unsafe (Rongotai Rd). **Therefore, being required to (unexpectedly) cross a dedicated cycle lane to board or alight the bus is likely to contribute to pedestrians feeling unsafe at bus stops.** This also suggests that some alighting passengers at Rongotai Rd may not notice the small buffer area of kerb between bus bay and cycle lane, as they perceive themselves as alighting directly into the cycle lane.

Unclear right of way: One possible explanation for the high proportion of ‘very unsafe’ responses at Rongotai Rd, especially when compared to Victoria St B is that the design at Victoria St requires cyclists to stop for pedestrians when a bus is present (whether or not they actually do), while the Rongotai Rd shared space creates an ambiguous area where cyclists may continue through even when pedestrians are using the space. However, pedestrians did not explicitly comment on the ambiguity of the Rongotai Rd site, and commented at both sites that cyclists are too fast. Therefore, it is not necessarily the case that a clearer indication of right of way would significantly increase perceptions of safety for pedestrians.

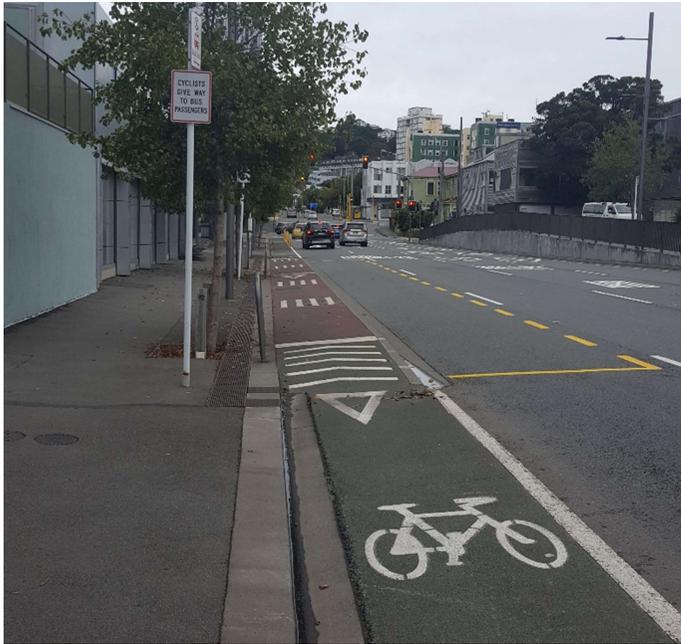
Stop 6711, Victoria St at Abel Smith St (Victoria St B)

Cycle lane passes between bus shelter and bus bay. Cyclists are required to give way to pedestrians.
Outbound. Daily boardings: 79, alightings: 86, total: 165

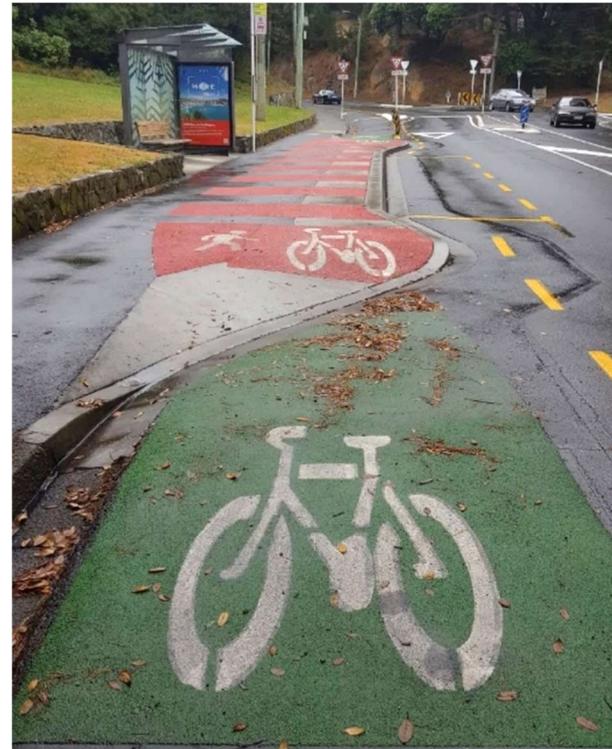
Stop 7023, Crawford Rd at Wellington Rd Roundabout (Crawford Rd A)

Cycle lane transitions onto footpath and passes between bus shelter and bus bay. Shared zone for cyclists and pedestrians is denoted by red stripes and painted symbols. Site is on an uphill gradient.
Inbound. Daily boardings: 47, alightings: 5, total: 52

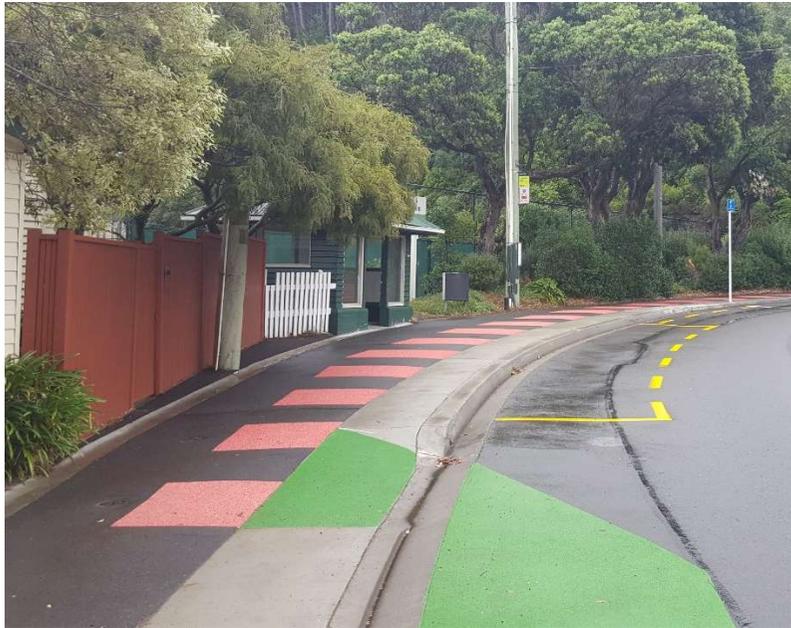
Stop 7024, Crawford Rd at Kilbirnie Tennis Club (Crawford Rd B)

Cycle lane diverts onto footpath and passes between bus shelter and bus bay. Shared zone for cyclists and pedestrians is denoted by red stripes. A white concrete strip provides a boarding and alighting area for passengers. Site is on an uphill gradient.

Inbound. Daily boardings: 75, alightings: 2, total: 77

Cyclists commented positively on the design or mentioned that the stop had low pedestrian traffic which made it easy to use. Both cyclists and pedestrians noted that the design was suitable because it was on an uphill section, which meant that cyclists travelled slower and were able to slow down and be aware of pedestrians. Several pedestrians also gave positive comments about the stop. Pedestrians and cyclists both mentioned that they needed to be aware at the stop and that it should be ok “if people share responsibly” and “are paying attention”. While several pedestrians felt that the markings at the site were not clear enough, a few cyclists commented favourably on the markings and none of the cyclist respondents in this survey described the stop as ambiguous or unclear.

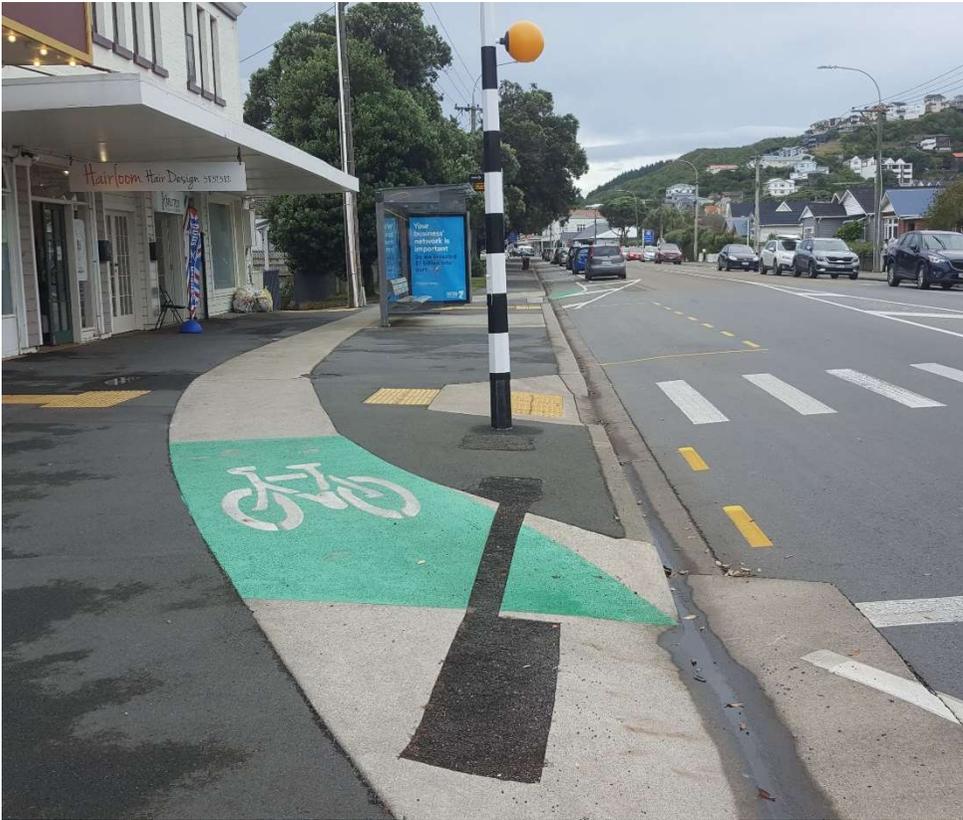
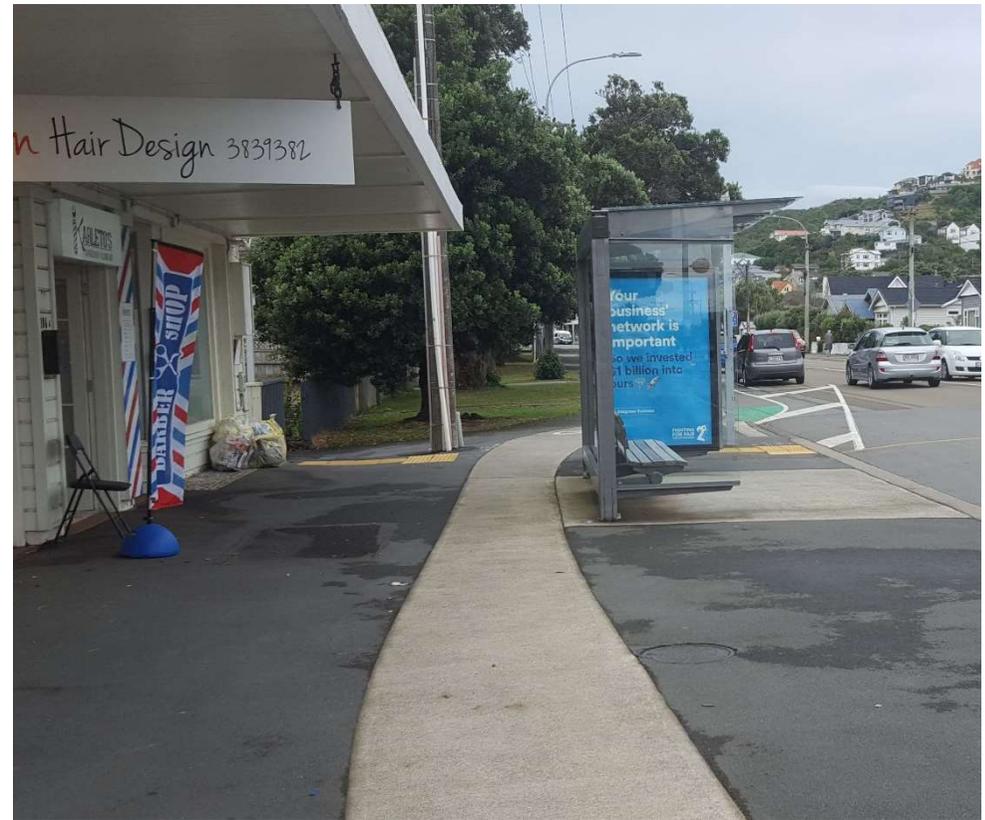
Stop 7133, near 206 The Parade, Island Bay

Cycle way diverts onto footpath behind bus stop.
Inbound. Daily boardings: 277, alightings: 1, total: 278

5. Increasing the visibility of the bypass behind the stop at Island Bay, for example, with markings on the cycle lane, could help manage pedestrian behaviour and increase feelings of safety for cyclists.
